**Engineering World Health January Institute  
2019 Uganda  
Final Report**

## Executive Summary

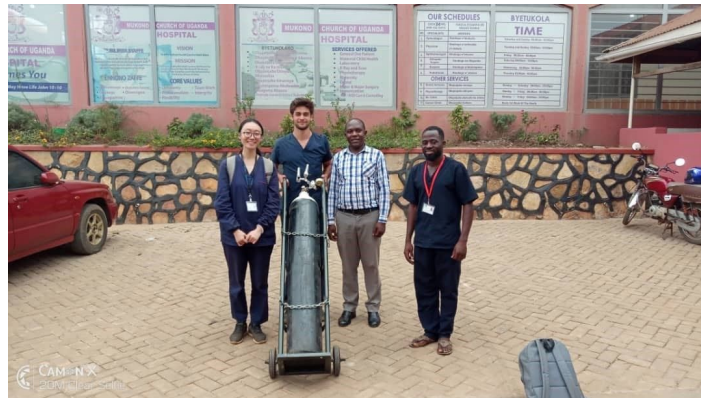
This group designed and built two oxygen tank trolleys to facilitate the safe transportation of heavy pressurized tanks. After assessing the needs at the hospital, it was evident that the facility was lacking a safe way to transport its pressurized oxygen tanks. This need for a trolley to safely transport the tanks was recognized by senior nursing staff and the hospital director.

After some research on different types of oxygen trolleys, dimensions, and weight specifications, a design was produced using CAD. Materials were purchased and brought to a local welder to construct two trolleys, using the designs provided. When the trolleys were finished, it was evident that the height dimension for the handles was not accurate. However, after successfully testing the trolleys, the hospital director approved their use at the hospital. Overall, the project was a success, as the oxygen tank trolleys achieved their purpose and were welcomed to the hospital with satisfaction.

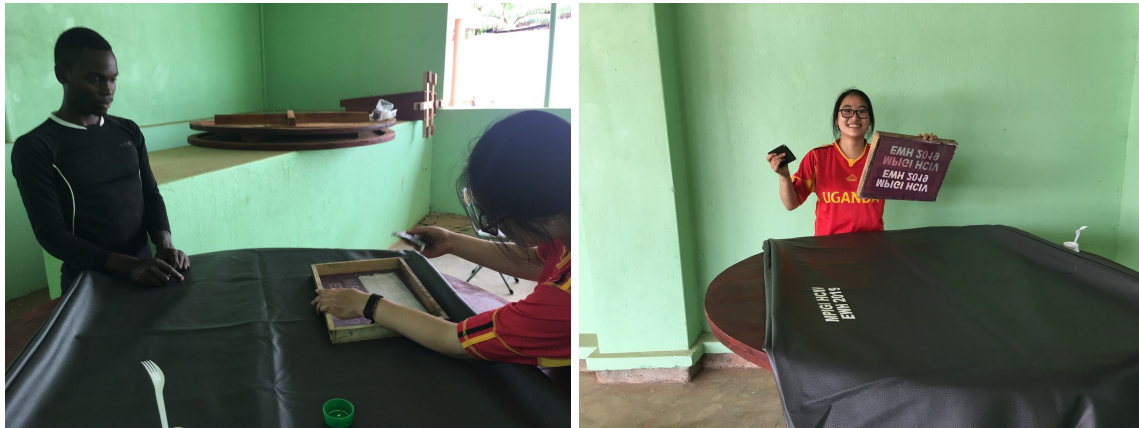
fluids do not soak into the mattresses. This would greatly help hygiene/ sanitation at the hospital and enable infection control. The students returned to Kampala to find PVC paint and the mackintosh covers, had them made into sheets by a tailor, then transported them back to Gombe. They then printed “MPIGI HC IV EWH 2019” on all of them using a screen and PVC paint. The participants noted that this process enabled them to build a stronger relationship with their landlord, as he was very passionate and great at art.

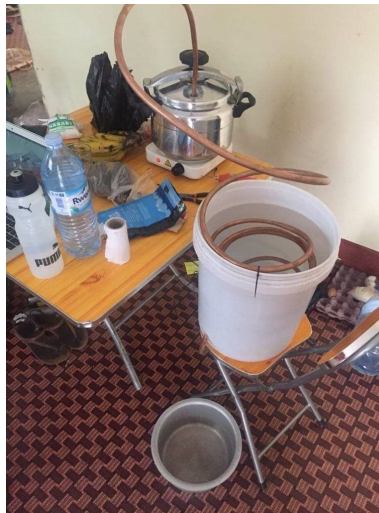
Distiller

Their distiller design consisted of a 7L pressure cooker, 1000W hot plate, copper tubing and a 20L bucket for condensing. They removed the pressure valve from the lid of the pressure cooker and inserted one end of the copper tubing into this, then sealed it with o-rings, epoxy, and silicon. They then coiled the remaining tubing to be placed into the condensing bucket and secured this with a zip-tie at the top of the

bucket. It took two attempts at condensing the steam to find a successful method. They used a paint bucket which was made of stronger plastic and used a small drill to create the hole instead of a blade (used in the first attempt), which created a more uniform hole without applying excess pressure. They sealed the tube in the hole with epoxy and then silicon. They encountered the problem of water getting trapped in the condensing tube. This was caused by the coil running 'uphill' in places and reducing the flow of water. They fixed this by ensuring the coil in the bucket was constantly descending.

At Entebbe General Hospital there was no way to procure distilled water to be used in medical equipment, so rain water was used instead. This is damaging to equipment and can cause infections easily, so as a secondary project this group decided to create a water distiller for use in critical departments.

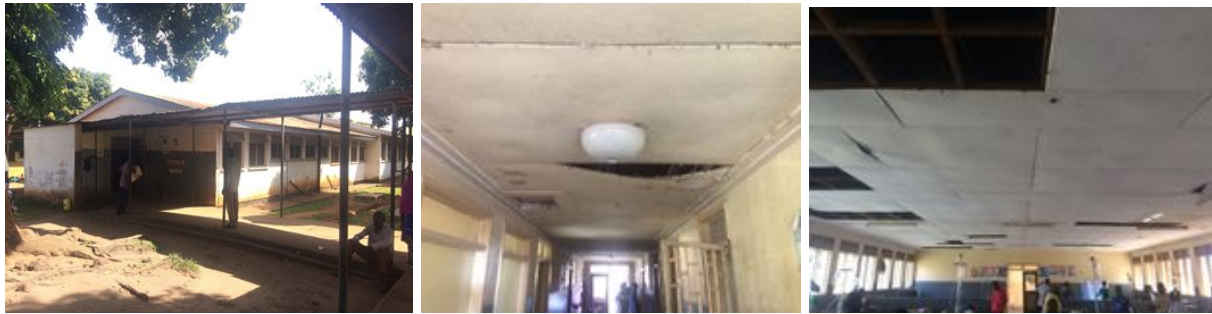
Before

Their Secondary Project was to renovate the Female Ward, as it is in the worst state of all the wards, which impacts both the patients and the equipment. The ceiling

boards were missing and damaged in many places. The walls on the inside and outside were damaged and old. The group felt that negative perception of the importance of maintenance in the ward led to the equipment being neglected. The administrator of the hospital has had this concern and suggested this project himself. Almost every single piece of equipment in this ward required repair and had been repaired the previous year due to similar problems.

The proposed renovations involved replacing the missing and damaged ceiling boards before painting the ceiling. The next step was to sand and repaint the walls on the inside and outside of the Ward. The students posted their project on XXXX and raised funds to cover the excess costs.

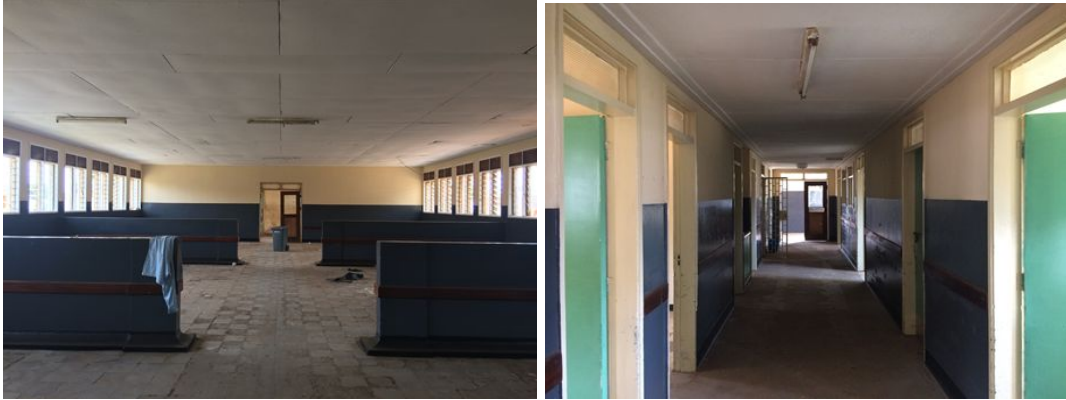
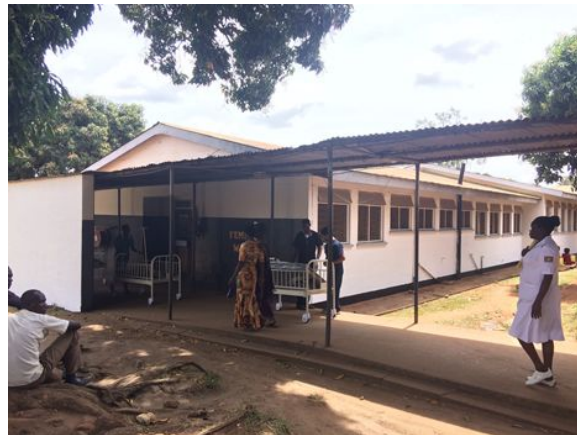
They were fortunate enough to raise 1,356 NZD which is 3,375,415 UGX (US \$922). They spent 2,564,300 UGX on the female Ward and 831,000 UGX on spare parts. After photos included below:

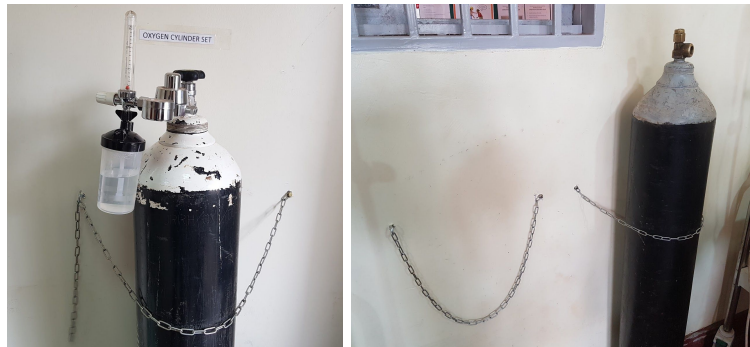
Installed Chains

This group's secondary project was to install harness chains for oxygen cylinders throughout the hospital. Oxygen cylinder use is highly prevalent throughout hospitals, however the safe practices associated are sometimes not. Oxygen cylinders are highly pressurized, thus pose a high level of danger when damaged. It is not uncommon to find oxygen cylinders stored without any restraints. Combine this with a fast-paced environment and accidents are more likely to occur. The group decided to use Dyna bolts and a hook screw as the fixings. Installation in the emergency ward went particularly well. Although repeated visits were necessary, they were able to install the chains next to each bed, which was important as the emergency ward is small, busy, and a major user of oxygen cylinders. For the other wards, limited space and window placement made it so the chains could not be installed in the originally

planned manner. Instead, they focused on installing the chains at the oxygen cylinder storage areas for each ward.

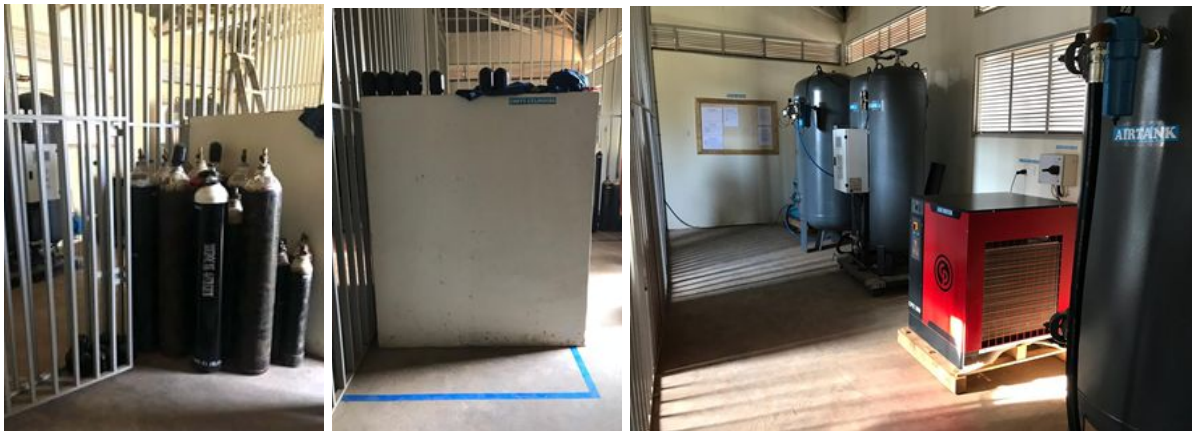
Oxygen plant after secondary project: labels on all tanks and machinery, including on outlets.

They organized the oxygen cylinders in different places in the plant so that it was easy to tell which cylinders were filled and which were empty. These places were then labelled so that it became clear which groups of cylinders were full, empty, and faulty, respectively. As other hospitals or other healthcare providers in the area must travel to this plant in order to refill their oxygen tanks, visitors often come to and interact with the plant, even when they are not aware of the organization system. So they also labelled the machinery in the plant so it was clear which parts could pose more potential risk or danger. It also helped to clarify which parts needed maintenance.

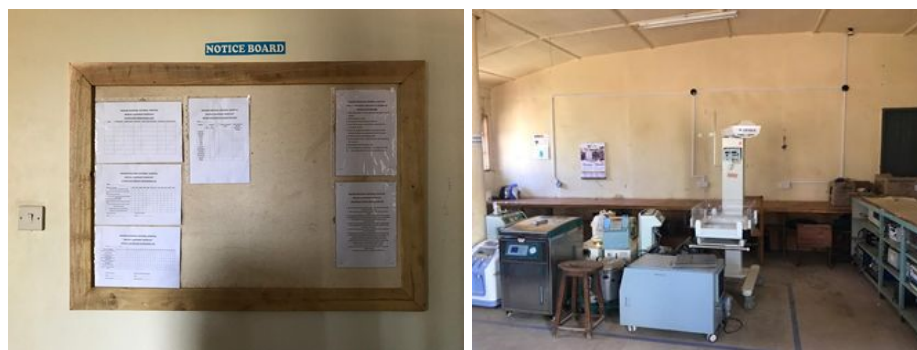
Noticeboard and organized space.

They created a noticeboard which tracked maintenance so that the hospital staff could easily keep track of when required maintenance was done. The engineering team did not have a way of recording regular needed maintenance. The only records kept within the plant were records of tank fillings. The group decided it was necessary to create a noticeboard so that it was clear to any person entering the plant whether maintenance had been done regularly. The board also meant that the records would be kept in one place and not moved or potentially lost.

They made two more noticeboards to be put up in the engineering workshop, so that there would be a more central and permanent focus on the 5S system. The other noticeboard assisted the engineering department to have a more reliable space for tracking tasks, something central to the effectiveness of the team as a whole.

They group also reorganized the workshop in order to set a status quo under the 5S system. This meant that the hospital's engineering team did not have to reorganize themselves, but could instantly start following the new organizational system. Thus, the transition to a more organized space was fairly smooth; there was very little disruption to the regular working of the department. The technicians were able to instantly interact with a neater workshop and use the space more effectively.
